John Coblentz Farm
Middletown
Private

INVENTORY FORM FOR STATE HISTORIC SITES SURVEY

John Coblentz Farm

F-2-7
 John Coblentz House
 Frederick County
 USGS Middletown, Md.
 Corrected location and Inventory number
 (Formerly F-4-8)

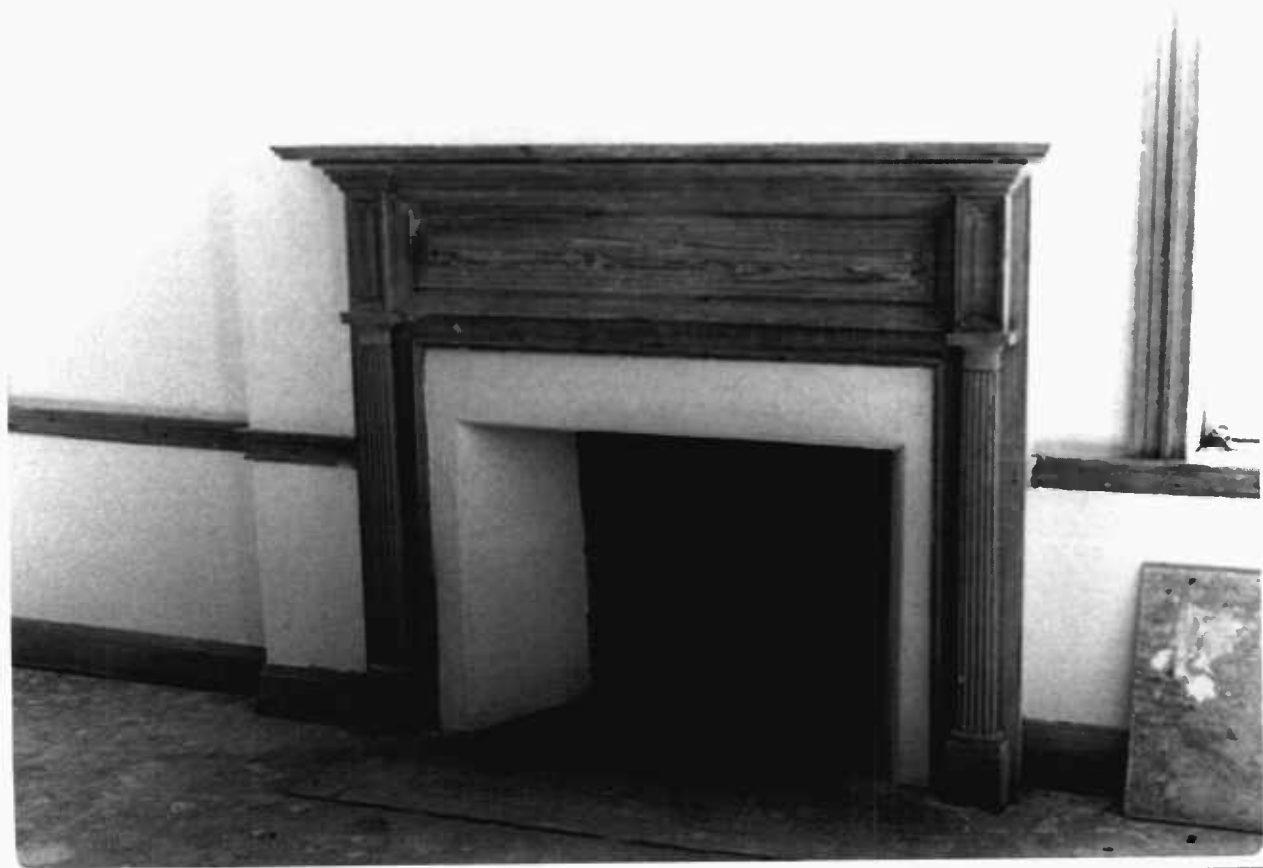
2ND FLOOR EAST

MANTTEL PIECE

The interior of the residence is a center hall floor plan with two room flankers. Original panelled windows, colonnaded mantelpieces, bull's-eye corner moldings and chair railing exist throughout the residence.

There is evidence of early wood marbling and on the mantelpiece carpentry methods which utilize the natural grain of the wood for ornamentation. The original paneled staircase with simple straight balusters and turned pilaster is located in the center hall. Original brass hardware exists on part of the first level.

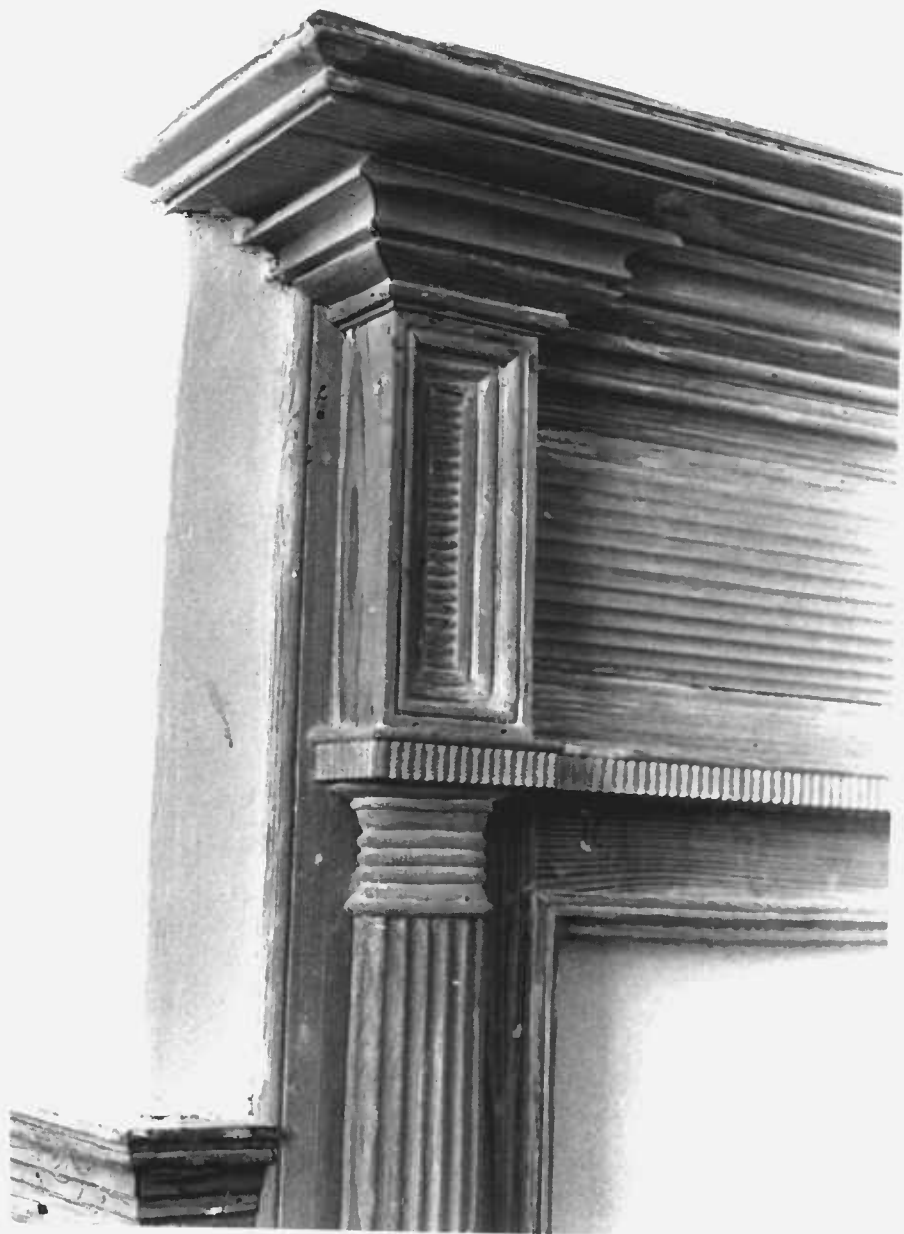
DETAIL EAST

MANTEL PIECE

Much of the interior woodwork bears close resemblance to the Asher Benjamin drawings of The American Builders Companion.
